All Estate Home Inspection

13800 SW 174 ST Miami FL 33177

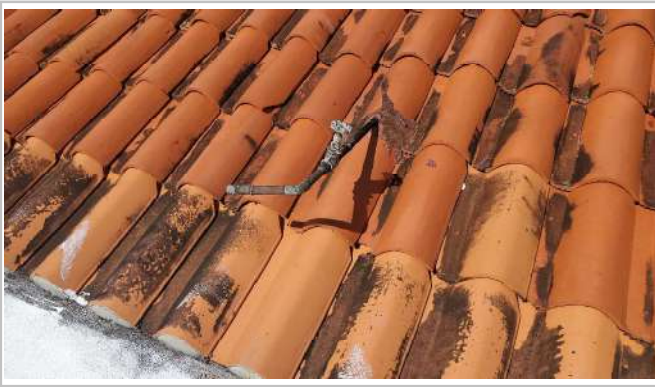
Concrete roof has 15 or more cracked tiles. Repair/replace as needed.

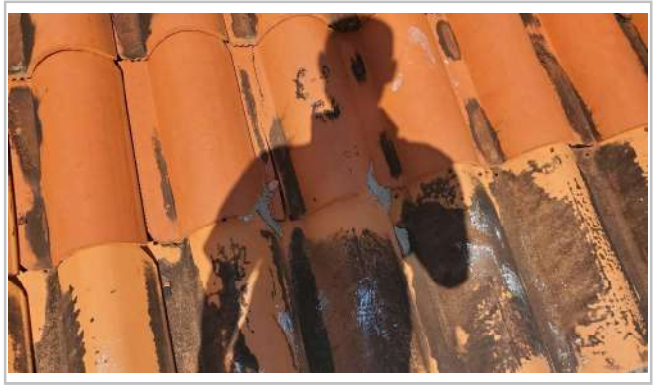
Concrete roof has 15 or more cracked tiles. Repair/replace as needed.

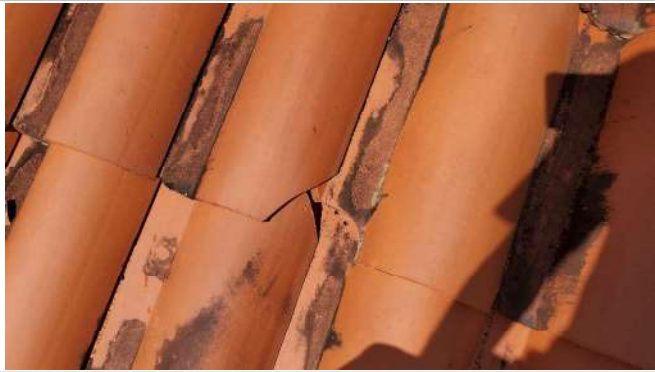
Concrete roof has 15 or more cracked tiles. Repair/replace as needed.

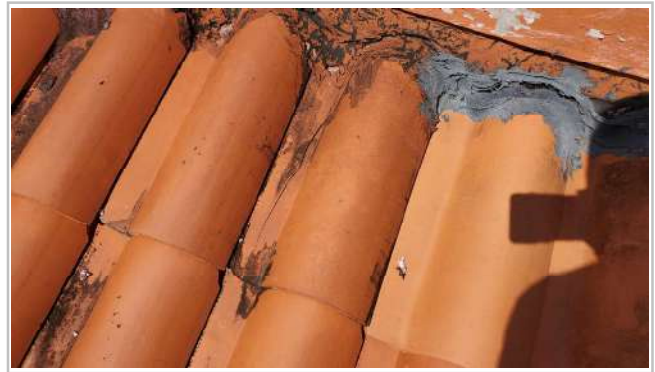
Concrete roof has 15 or more cracked tiles. Repair/replace as needed.

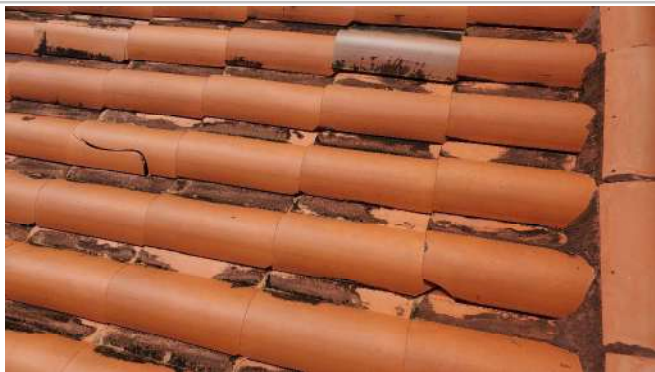
Concrete roof has 15 or more cracked tiles. Repair/replace as needed.

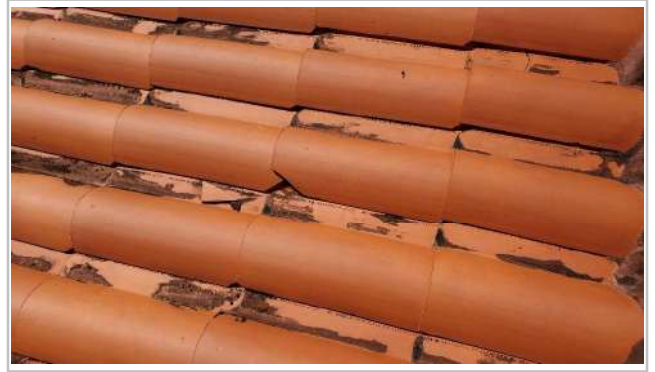
Concrete roof has 15 or more cracked tiles. Repair/replace as needed.

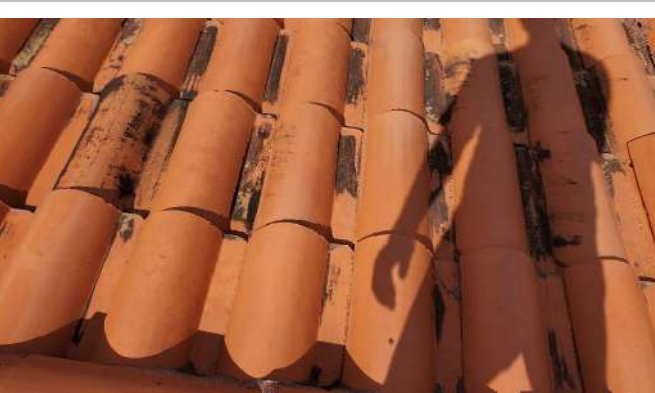
Concrete roof has 15 or more cracked tiles. Repair/replace as needed.

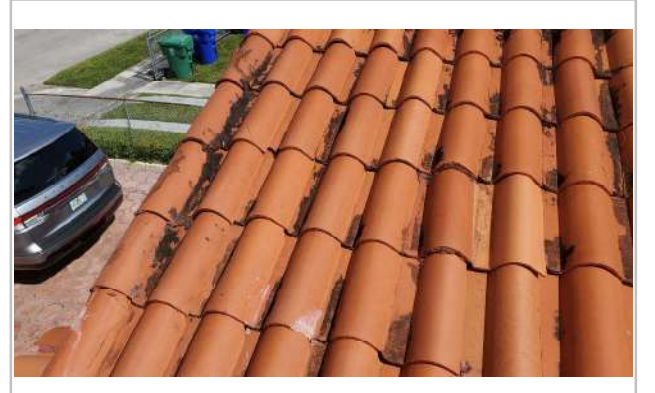
Concrete roof has 15 or more cracked tiles. Repair/replace as needed.

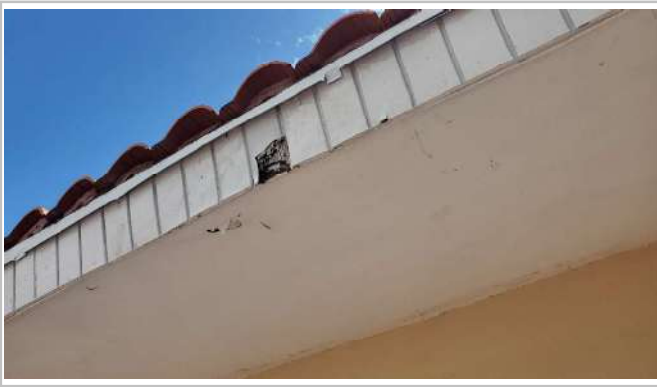
Fascia Board throughout the home has wood rot. Replace as needed.

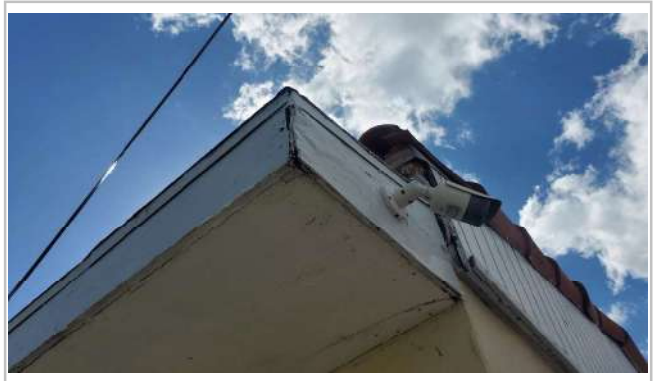
Fascia Board throughout the home has wood rot. Replace as needed.

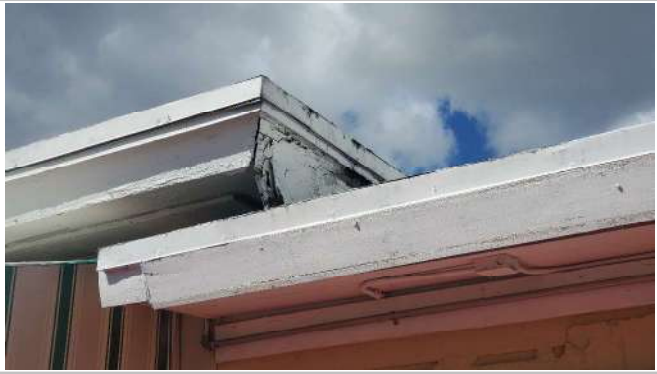
Fascia Board throughout the home has wood rot. Replace as needed.

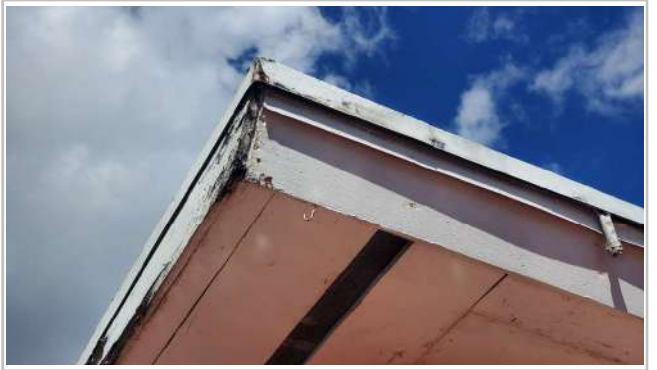
Fascia Board throughout the home has wood rot. Replace as needed.

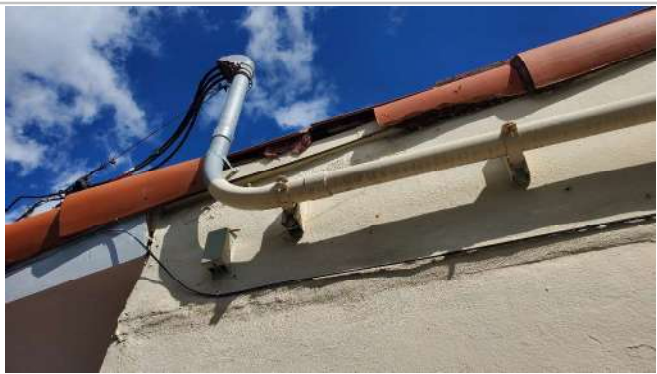
Right side roof tiles are missing. Replace as needed.

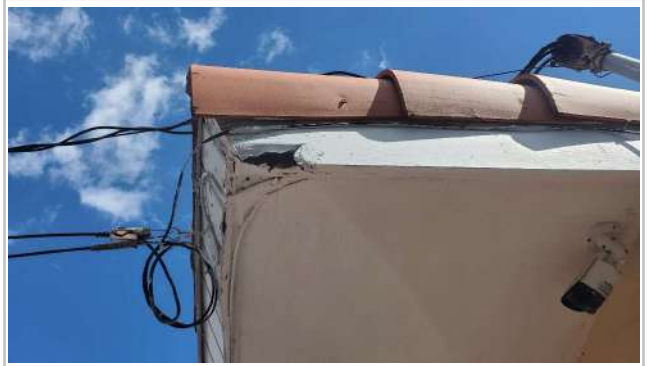
Fascia Board throughout the home has wood rot. Replace as needed.

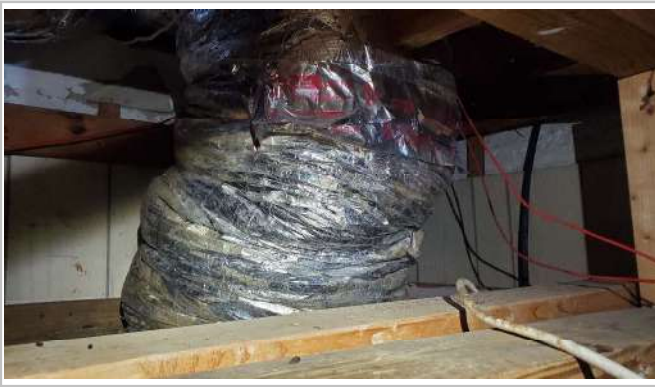
Garage attic air duct is torn. Replace as needed.

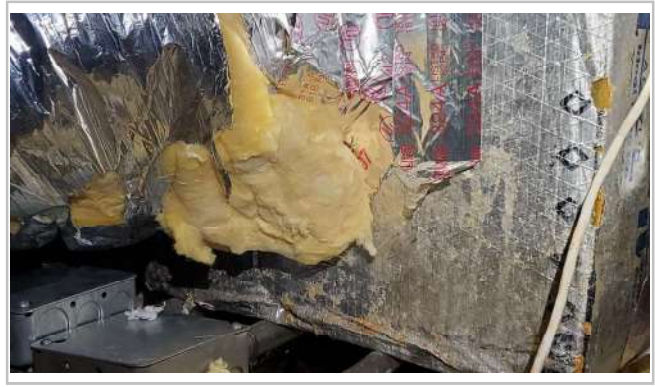
Garage attic air duct is torn. Replace as needed.

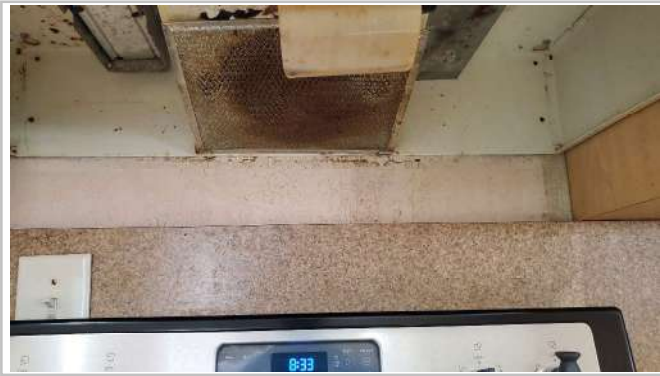
Kitchen exhaust fan filter is dirty. Replace as needed.

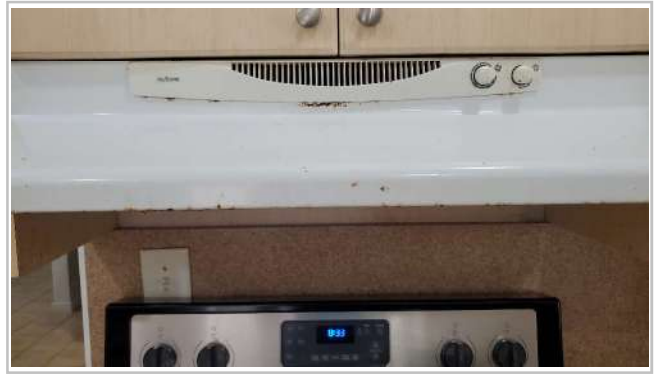
Kitchen exhaust panel is rusted.

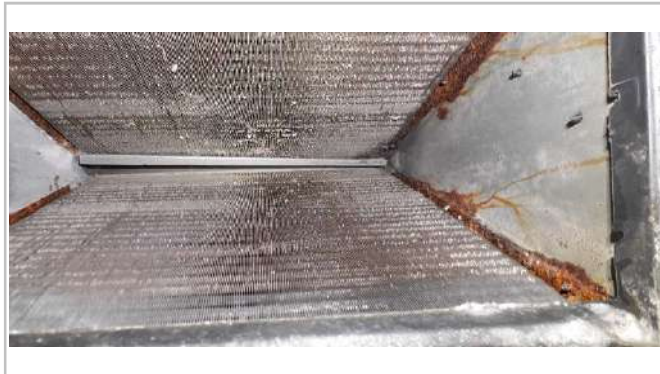
A/C air handler # 1 needs acid wash and flush. Repair as needed.

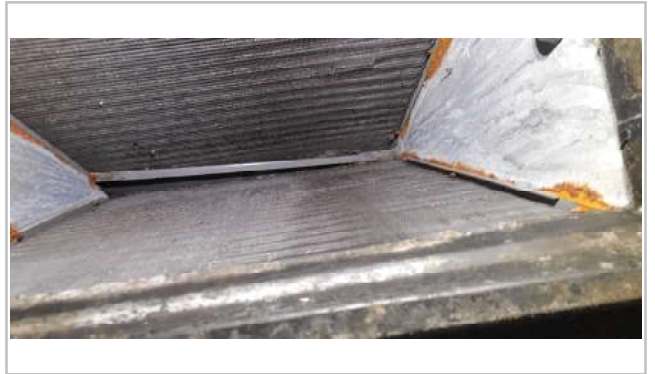
A/C air handler # 2 needs acid wash and flush. Repair as needed.

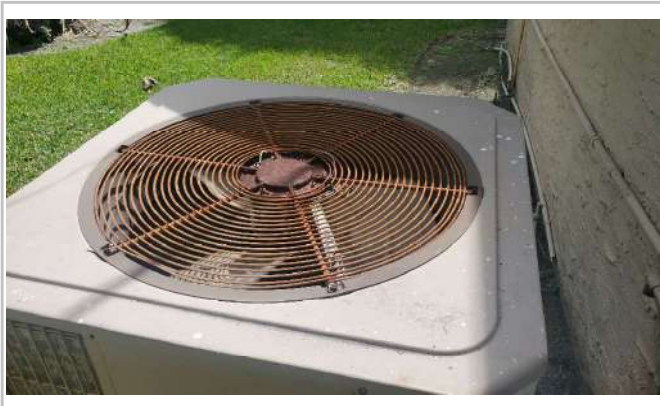
A/C air condenser exterior coil is damaged in the bottom. Replace as needed.

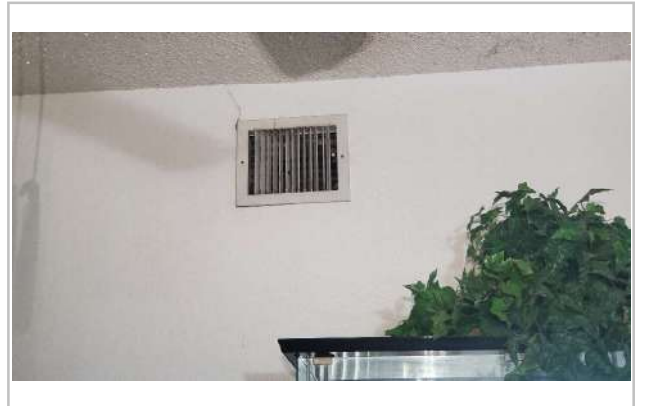
A/C air ducts need to be clean/repair/replaced, mold like substance found throughout the home walls. There was a

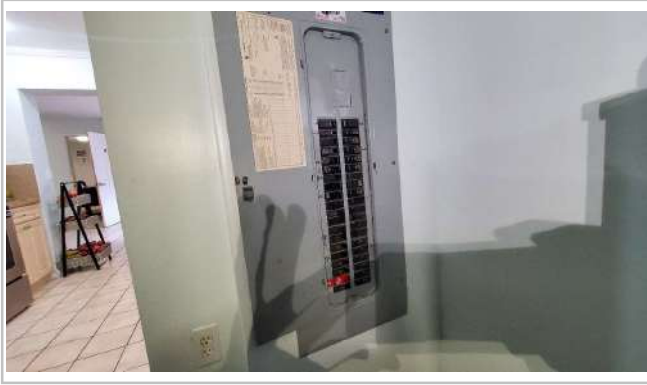
Electrical panel has cloth wires. Replaces as needed.

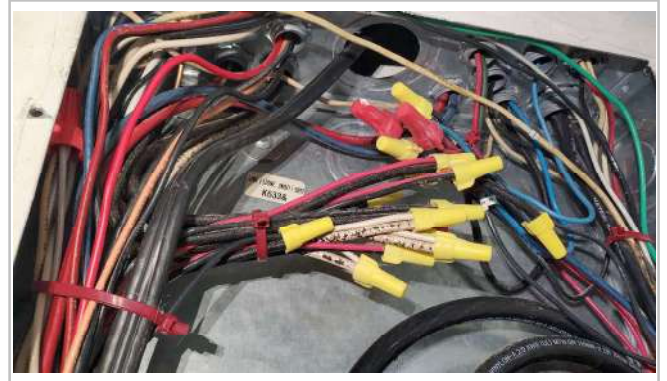
Electrical panel has cloth wires. Replaces as needed.

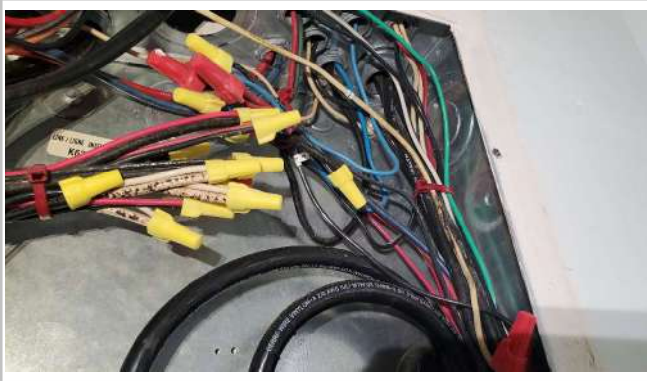
Electrical panel has cloth wires. Replaces as needed.

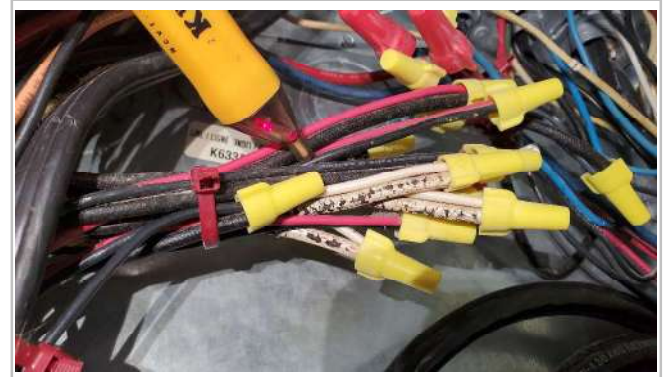
Electrical panel has cloth wires. Replaces as needed.

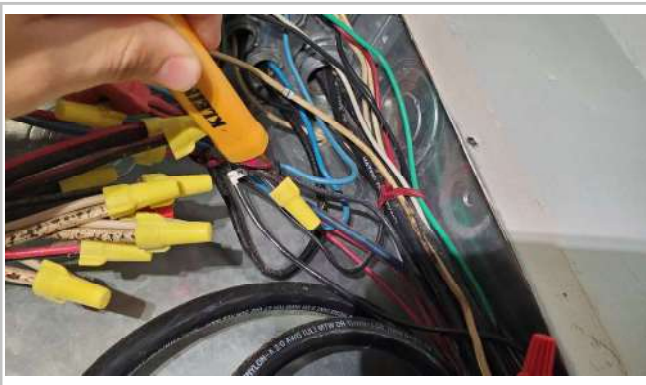
Electrical panel has cloth wires. Replaces as needed.

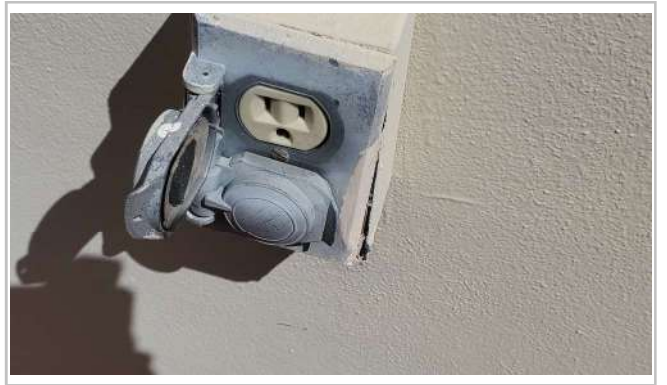
Rear outside electrical outlet needs to be GFCI. Replace as needed.

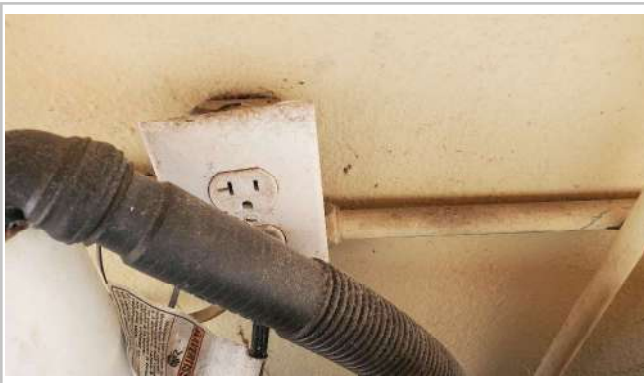
Rear outside electrical outlet needs to be GFCI and needs water proof cover. Replace as needed.

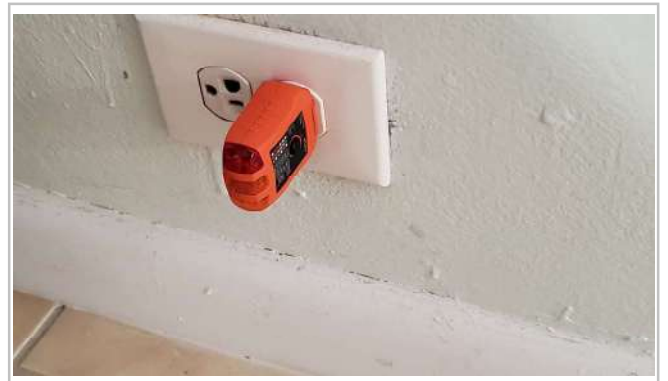
Master bedroom outlet has no power. Repair/replace as needed.

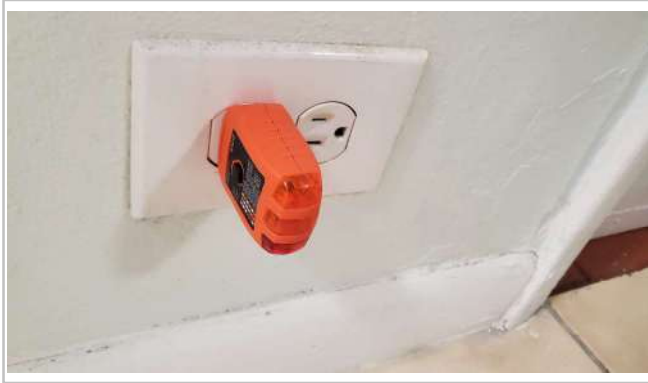
Master bedroom outlet has no power. Repair/replace as needed.

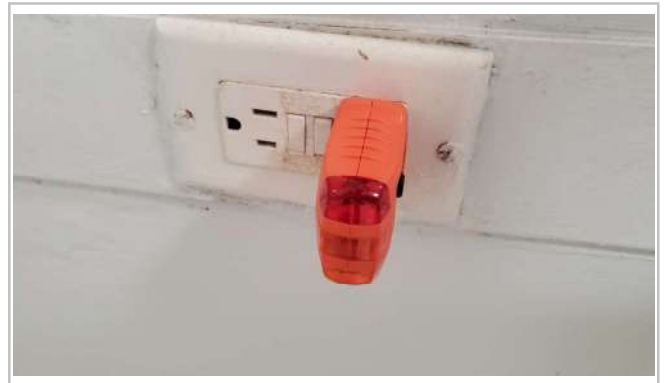
Master bathroom GFCI outlet is not working. Repair/replace as needed.

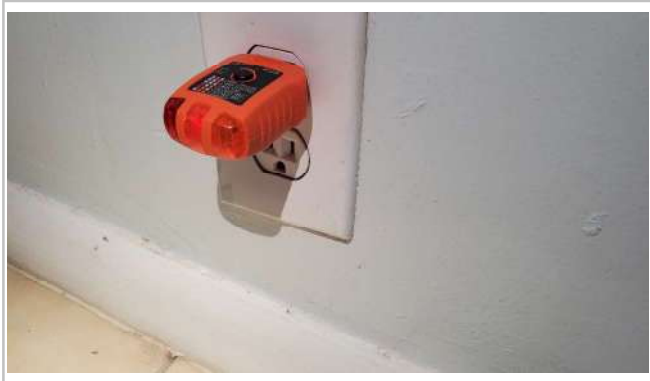
Bedroom # 3 outlet has no power. Repair/replace as needed.

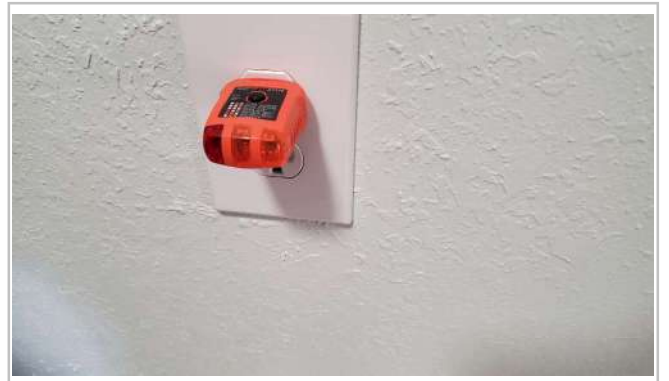
Dining room outlet has no power. Repair/replace as needed.

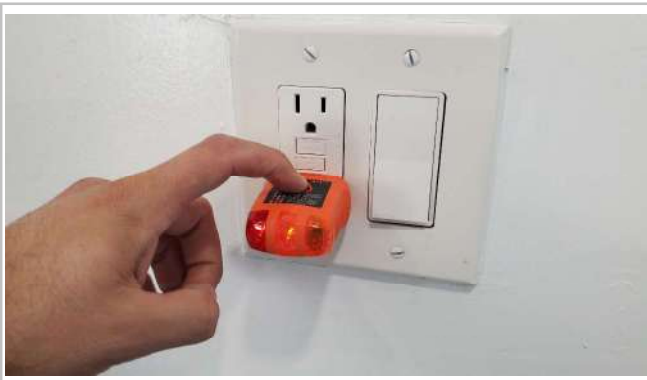
Bathroom # 3 GFCI outlet is not tripping. Replace as needed.

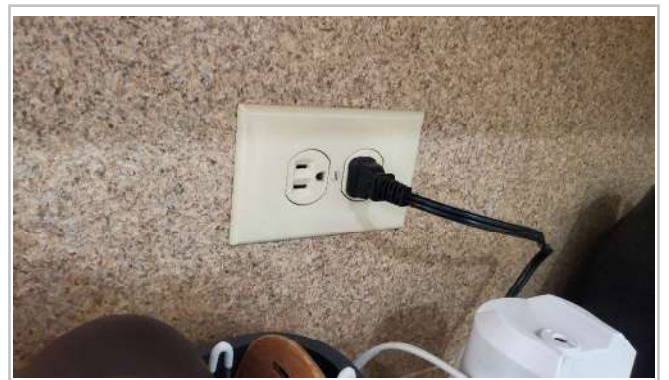
Kitchen outlet needs to be GFCI. Replace a needed.

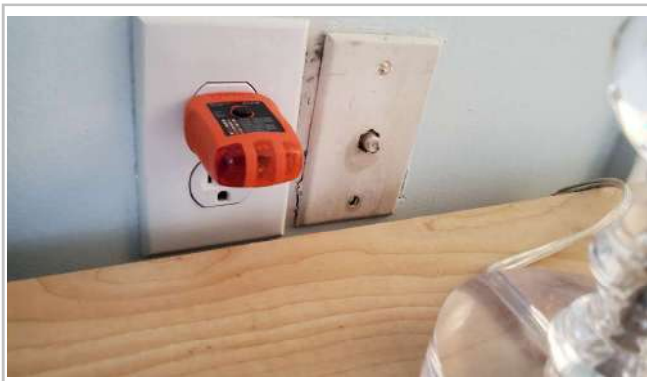
Living room # 2 outlet has no power. Repair/replace as needed.

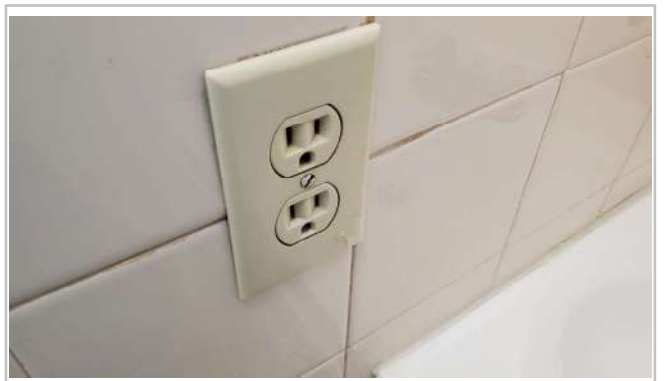
Bathroom # 4 outlet needs to be GFCI. Replace as needed.

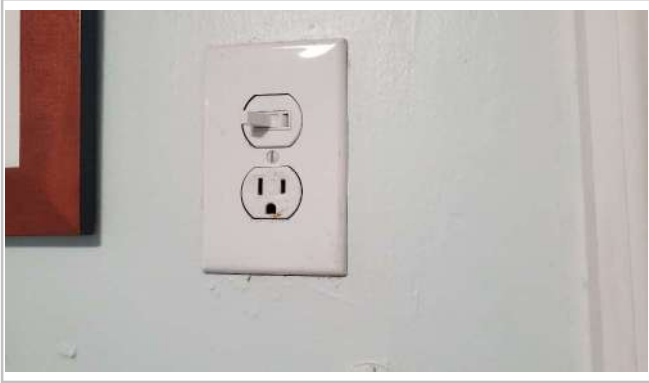
Garage outlet has no power. Repair as needed.

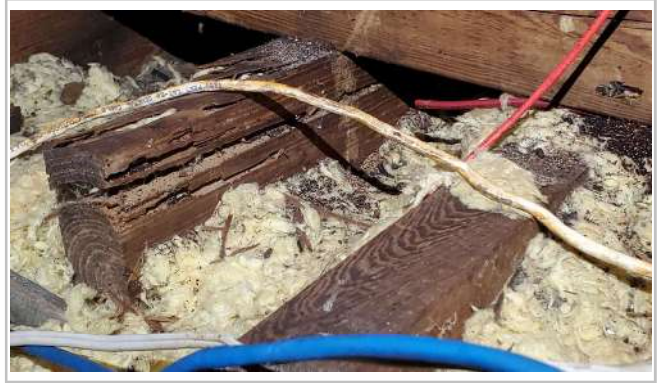
Cloths wires were found in attic with live power. Replace as needed.

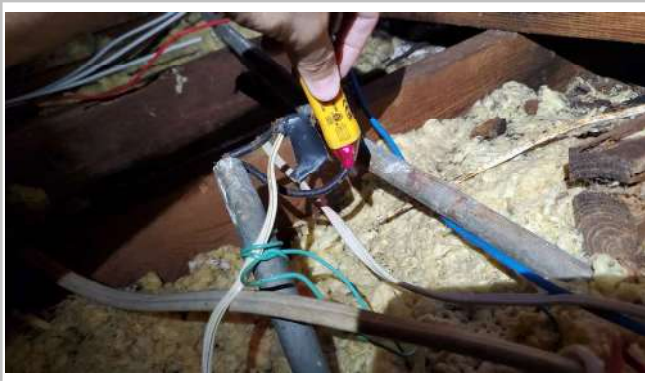
Cloths wires were found in attic with live power. Replace as needed.

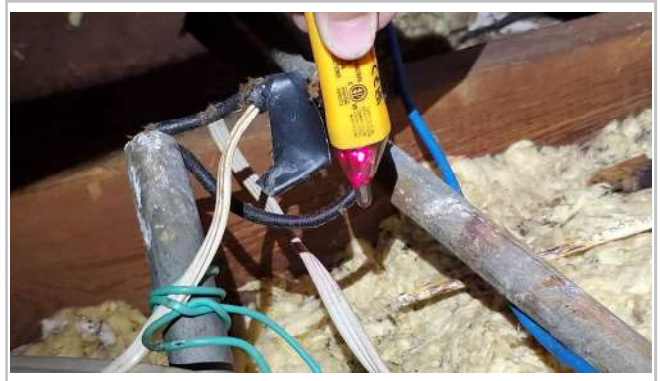
Cloths wires were found in attic with live power. Replace as needed.

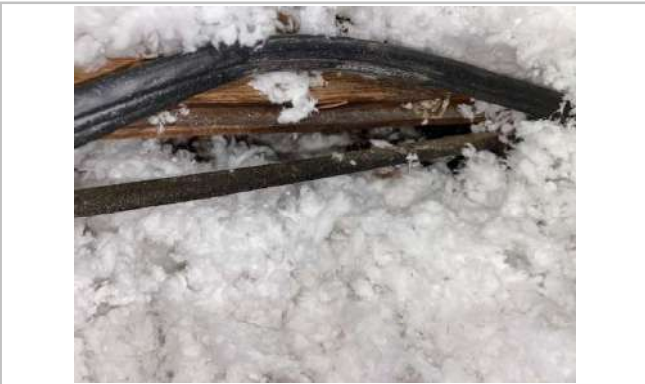
Cloths wires were found in attic with live power. Replace as needed.

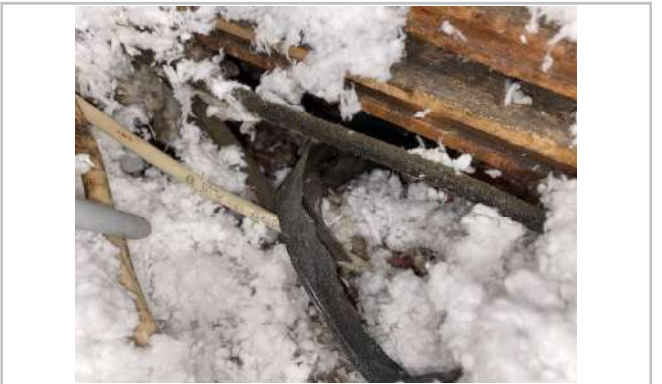
Cloths wires were found in attic with live power. Replace as needed.

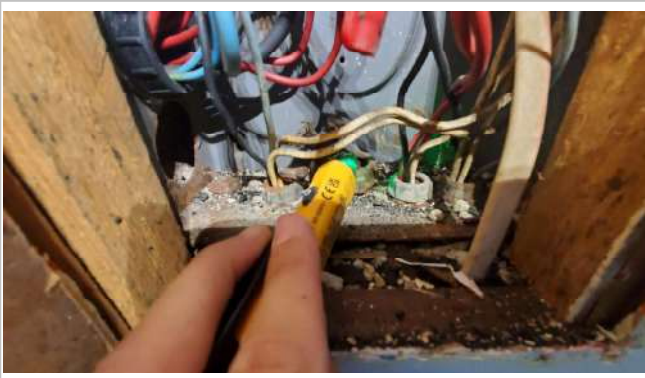
Original electrical panel view.

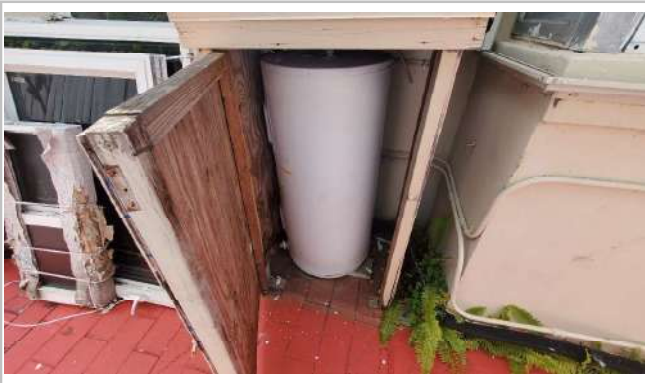
Water heater is outside the home, has a shed but is still exposed to the weather. Replace in the near future.

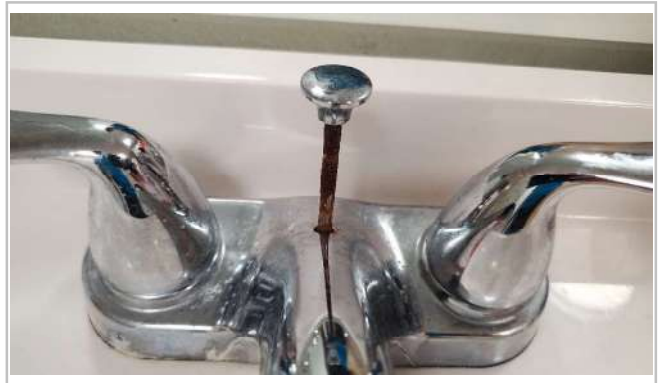
Master bedroom sink manual drain stopper latch is damaged. Replace as needed.

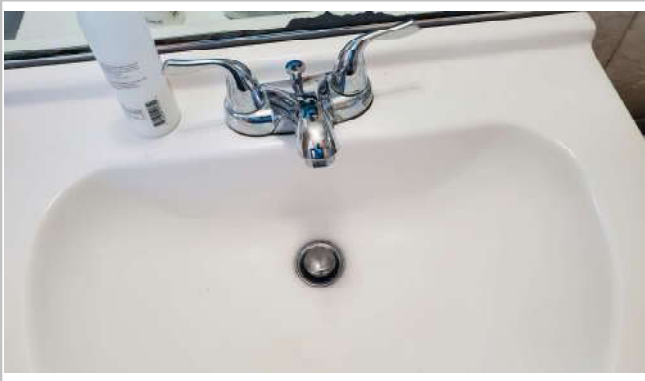
Bathroom # 2 sink manual drain stopper is damaged. Replace as needed.

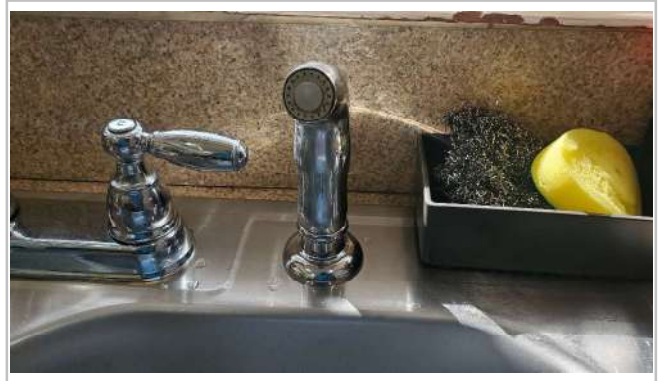
Kitchen faucet hose sprayer is not working. Repair/replace as needed.

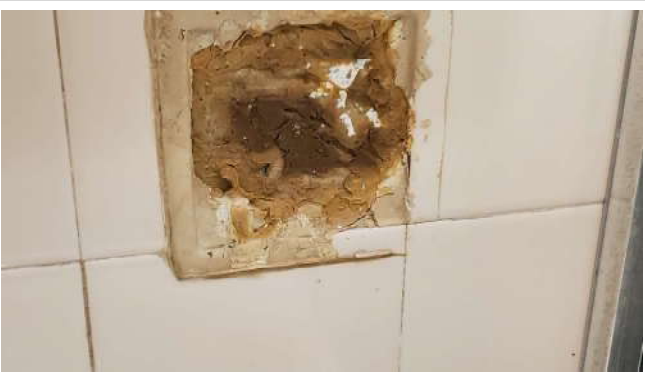
Bathroom # 4 soap holder is missing. Replace as needed.

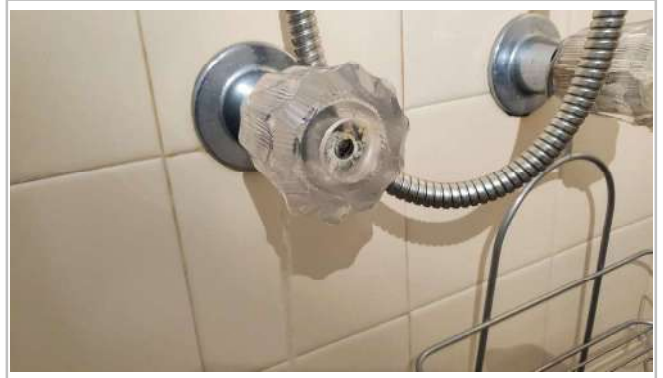
Bathroom # 2 shower knob is damaged when turned on, water comes out from it. Replace as needed.

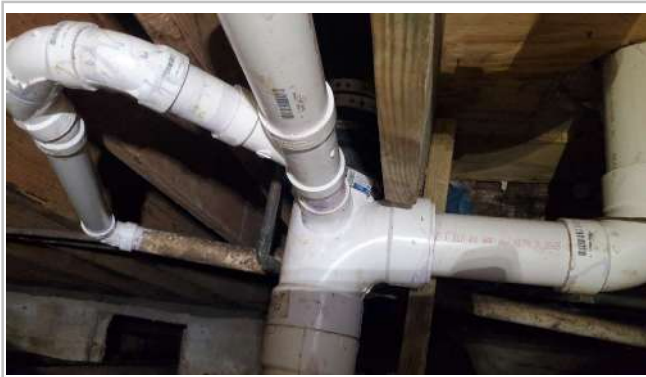
Crawl space PVC pipe view.

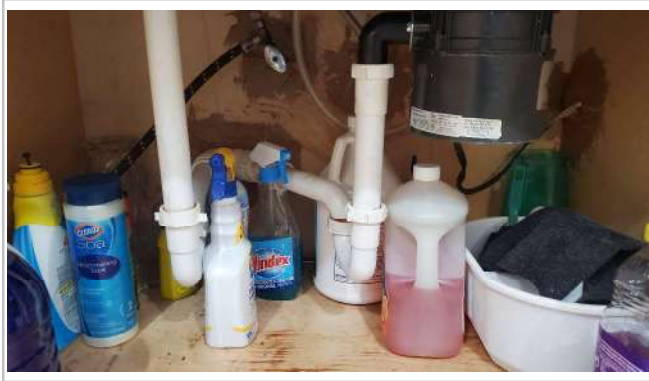
Kitchen cabinet is damaged near shut off valves. Replace as needed. +

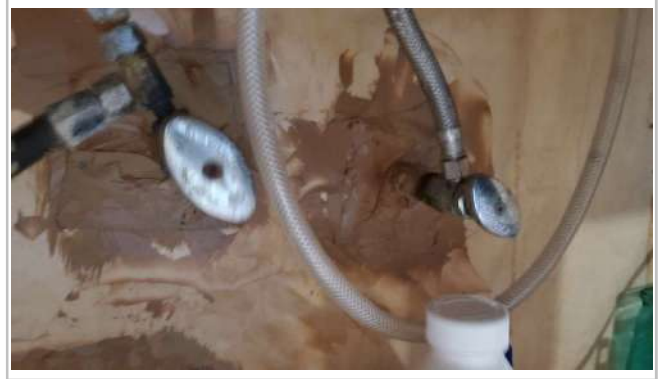
Kitchen cabinet is damaged near shut off valves. Replace as needed.

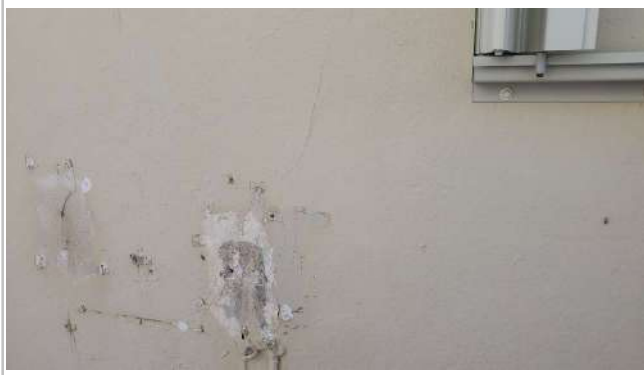
Right side outside wall has a stress crack. Repair a needed.

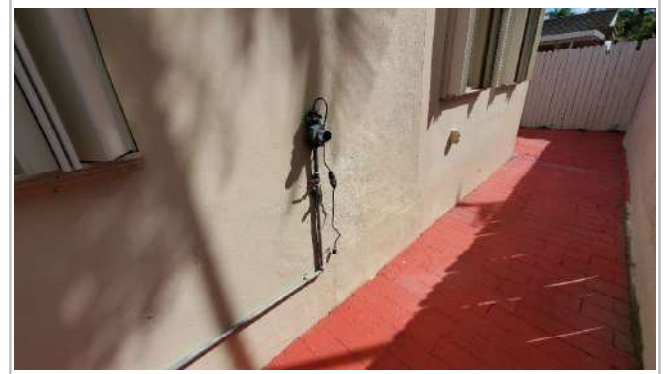
House use to have gas lines and were left behind. Remove as needed.

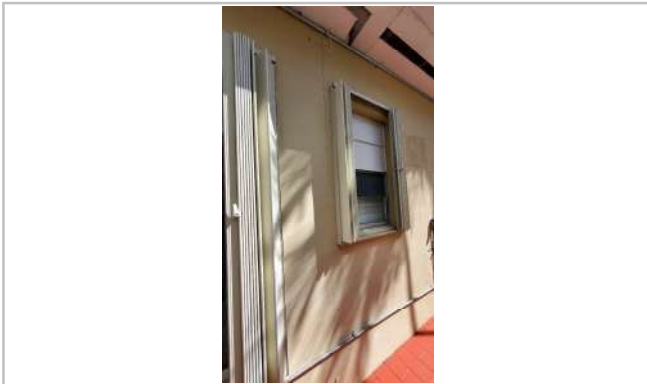
Large settlement crack found at right outside wall running vertical. Evaluation and repair by qualified licensed contractor for appropriate estimate recommended. +

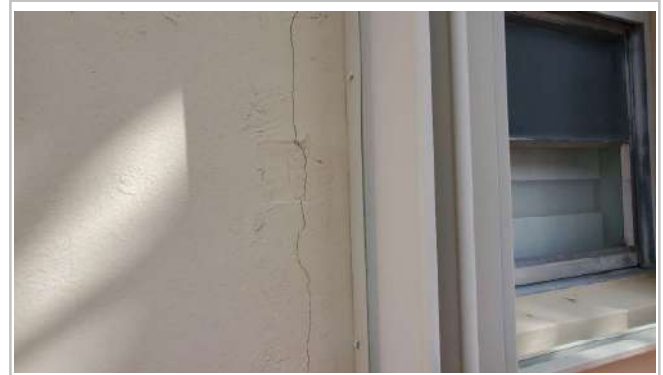
Large settlement crack found at right outside wall running vertical. Evaluation and repair by qualified licensed contractor for appropriate estimate recommended. +

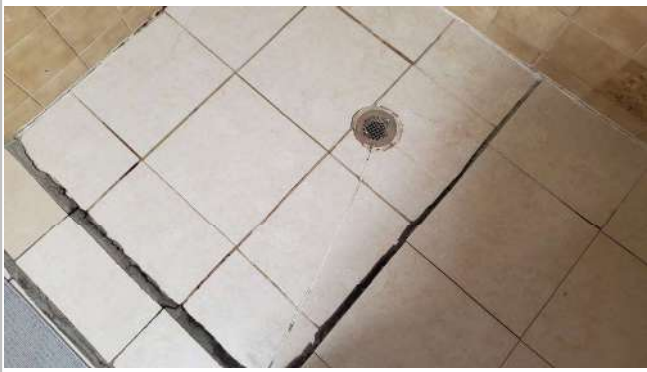
Master bathroom shower floor has 5 cracked tiles. Replace as needed.

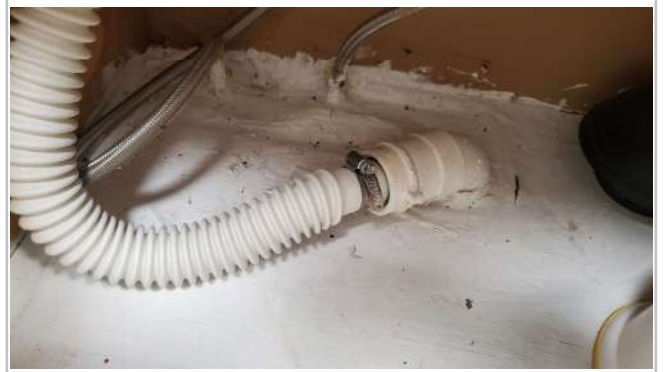
Master bathroom cabinet under sink is damaged. Replace as needed.

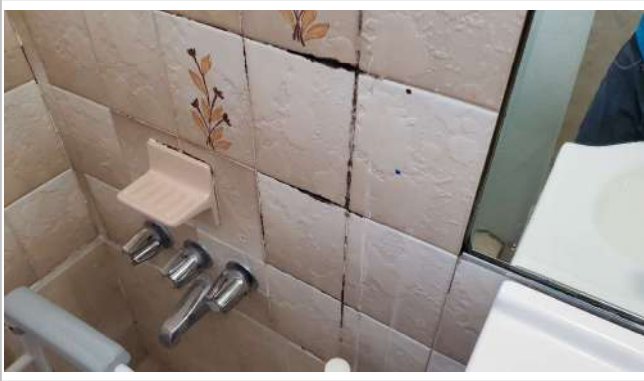
Bathroom # 2 shower needs to be resealed. Repair as needed.

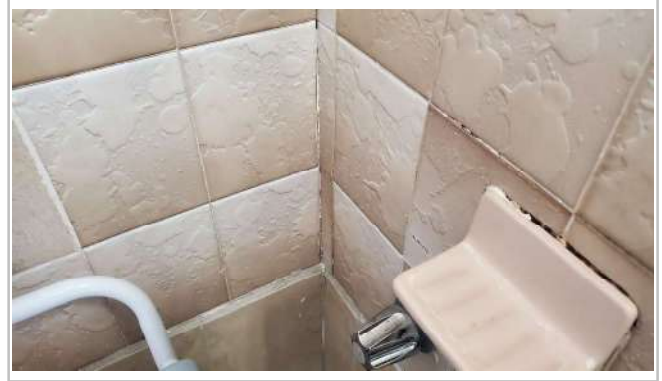
Bathroom # 2 shower needs to be resealed. Repair as needed.

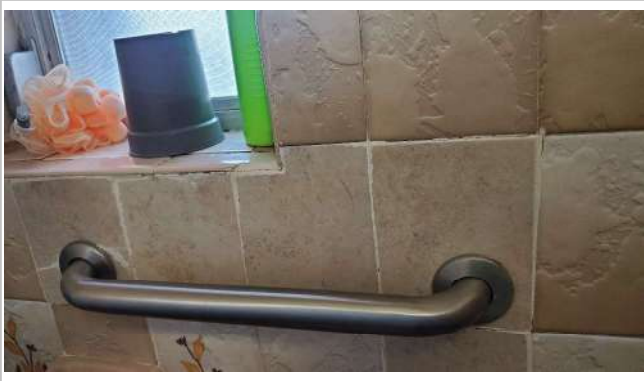
Bathroom # 2 has 3 cracked tiles in the wall. Replace as needed.

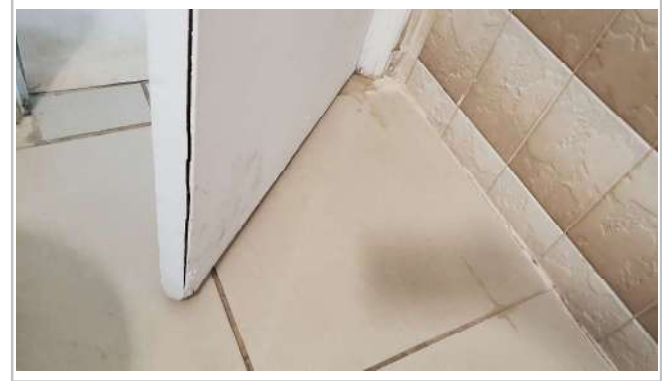
Bathroom # 3 door is damaged in the bottom. Replace as needed.

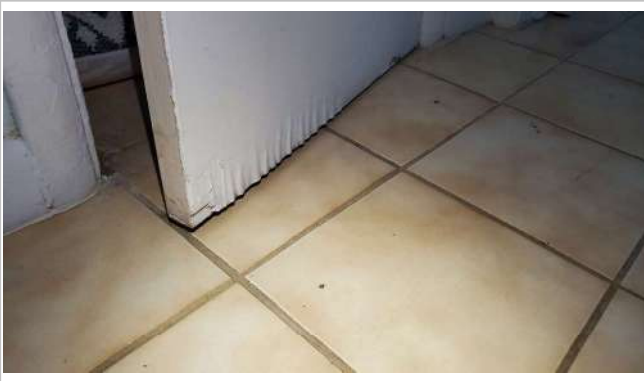
Hallway closet door is damaged in the bottom near bathroom # 3 Replace as needed.

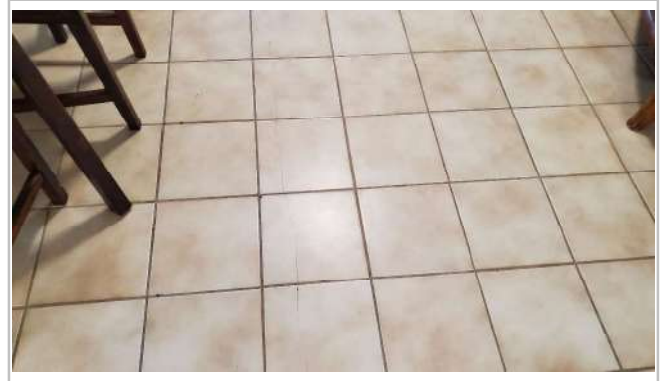
Dining/ living/ family room has over 20 cracked tiles. Replace as needed.

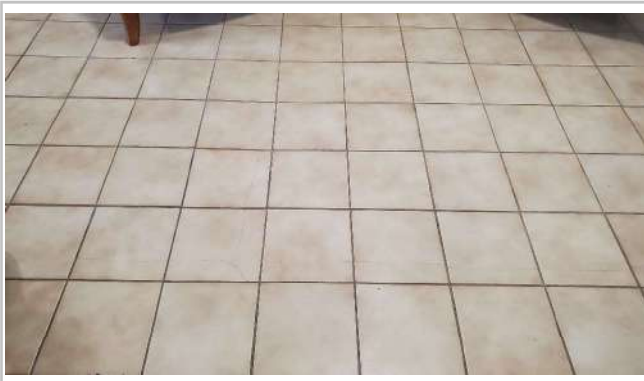
Dining/ living/ family room has over 20 cracked tiles. Replace as needed.

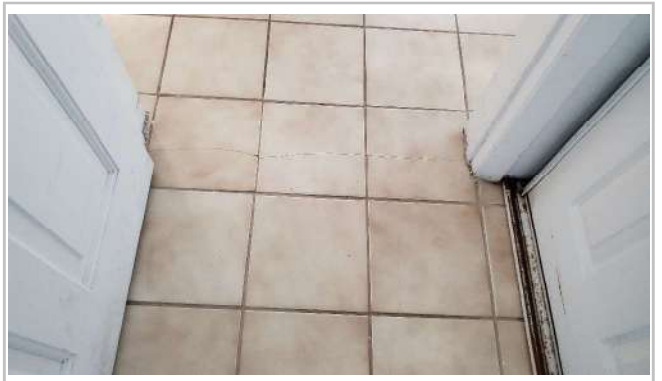
Bedroom #4 has 3 cracked tiles. Replace as needed.

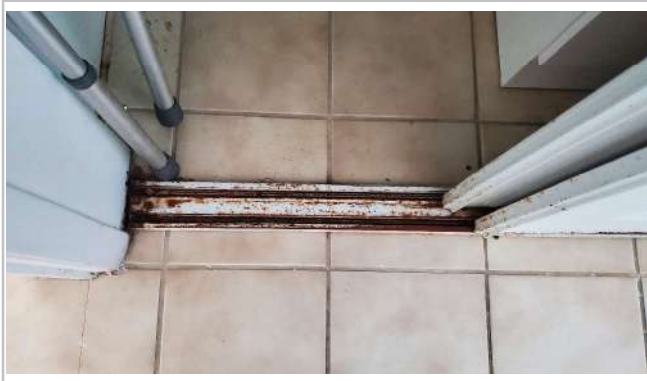
Bedroom #4 sliding closet door rail is rusted. Replace as needed.

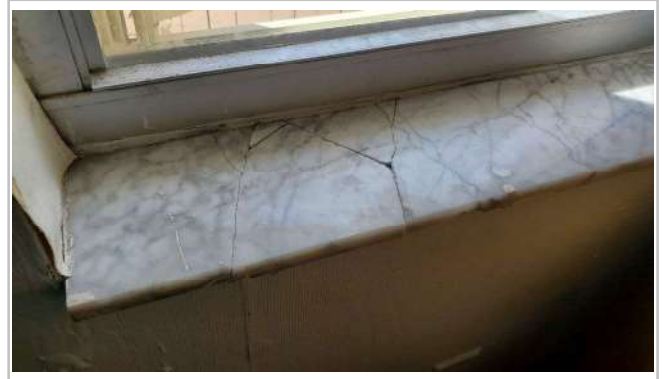
Living room #2 window sill is damaged. Replace as needed.

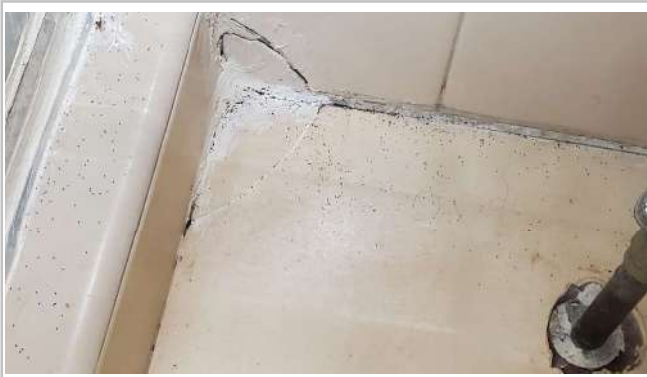
Bathroom #4 floor near toilet has termite droppings. Termite tent recommended.

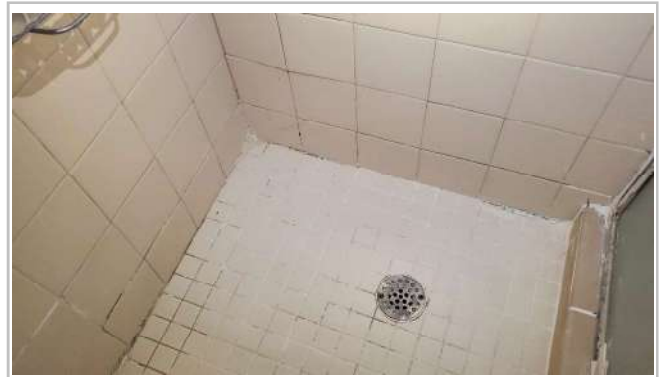
Bathroom # 4 shower needs to be resealed. Repair as needed.

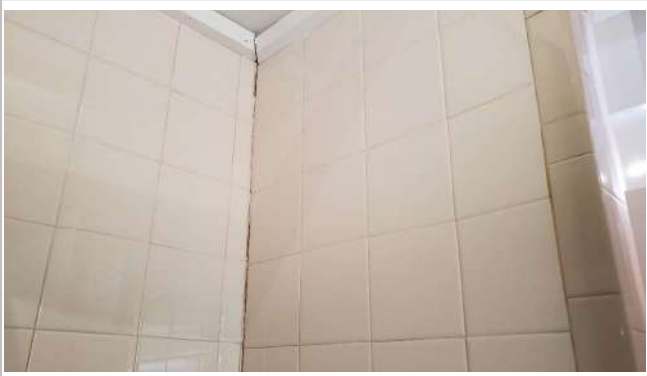
Bathroom # 4 shower needs to be resealed. Repair as needed.

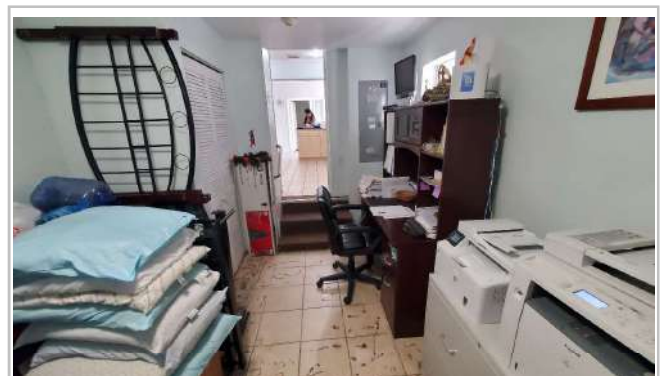
Garaged walls could not be fully inspected due to furniture.

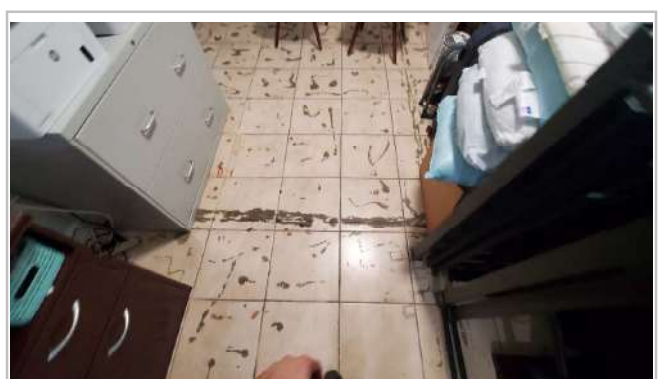
Garage tile floor has glue all over it. Remove/replace as needed.

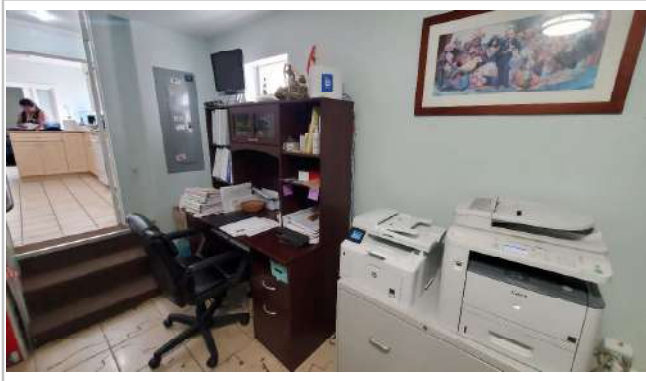
Garaged walls could not be fully inspected due to furniture.

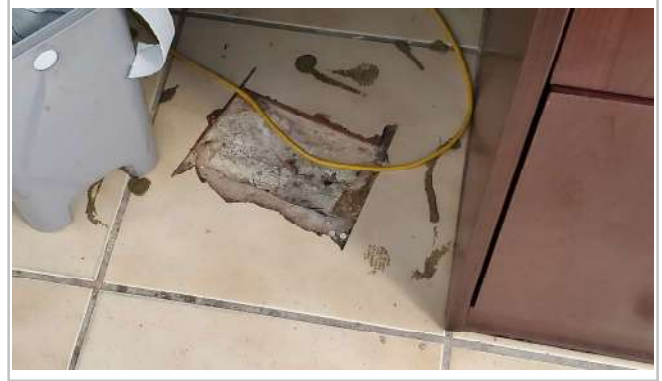
Garage floor is damaged under office area. Replace as needed.

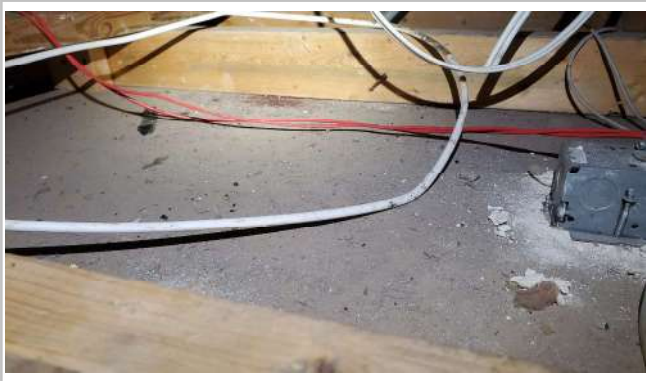
Found termite droppings and wings in garage attic. Termite tent recommended.

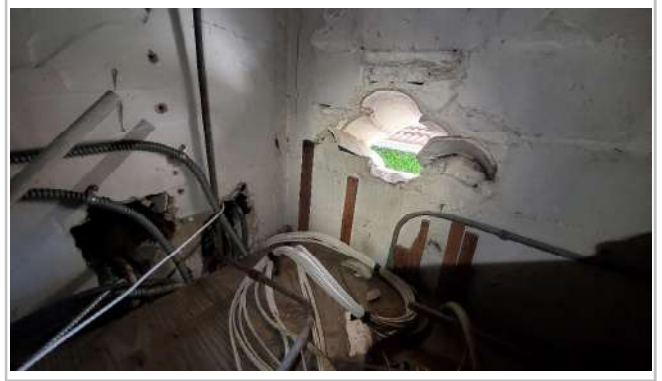
Attic ceiling has hole leading to outside. Wild life and moisture could come in. Repair as needed. Pest control recommended.

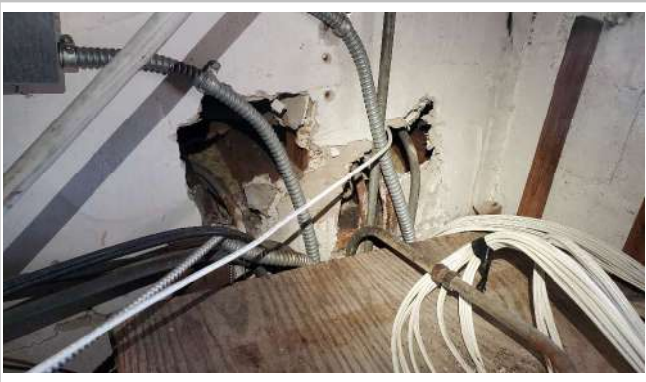
Attic has hole. Wild life and moisture could come in. Repair as needed. Pest control recommended.

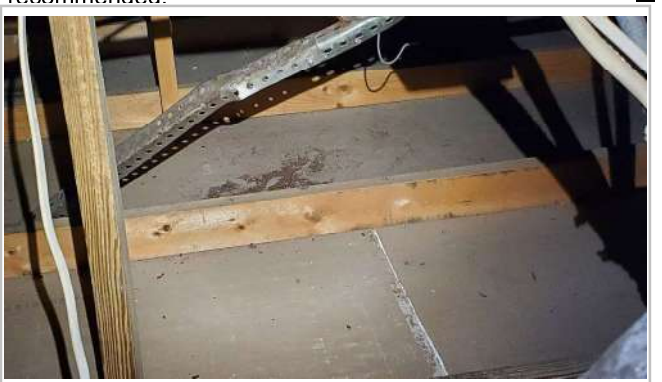
Found termite droppings and wings in garage attic. Termite tent recommended.

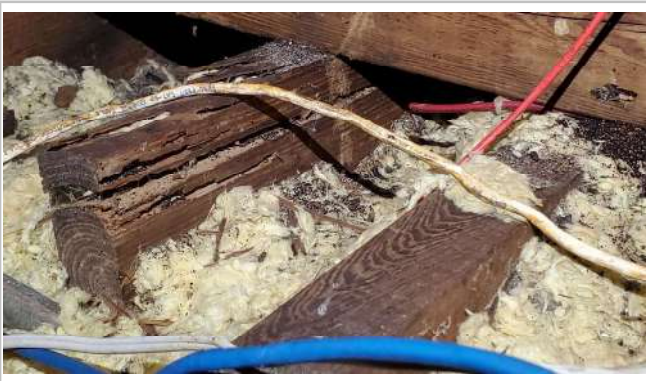
House main attic has wood rot due to termites. Termite tent recommended.

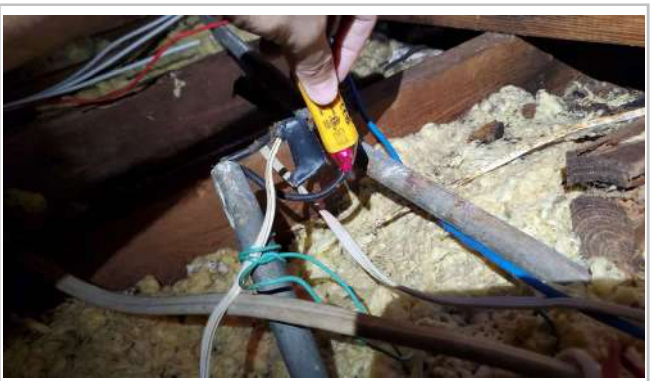
Cloth wires found in the attic with power. Replace as needed.

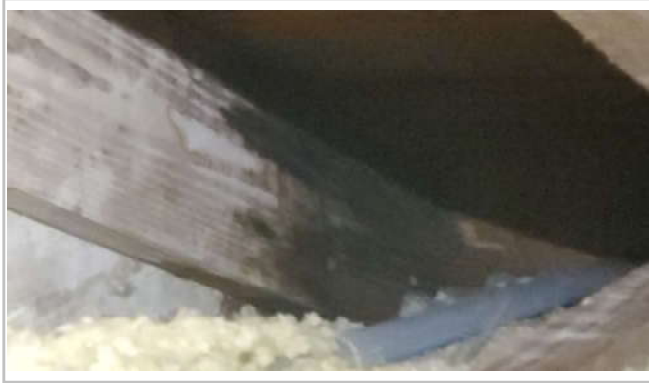
Attic beam has wood rot from previous leak. Repair/replace as needed.

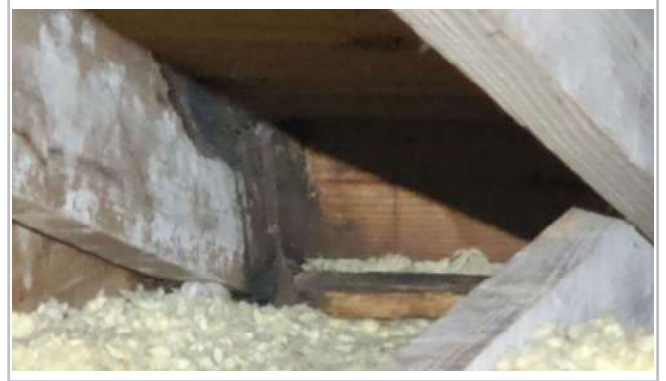
Attic beam has wood rot from previous leak. Repair/replace as needed.

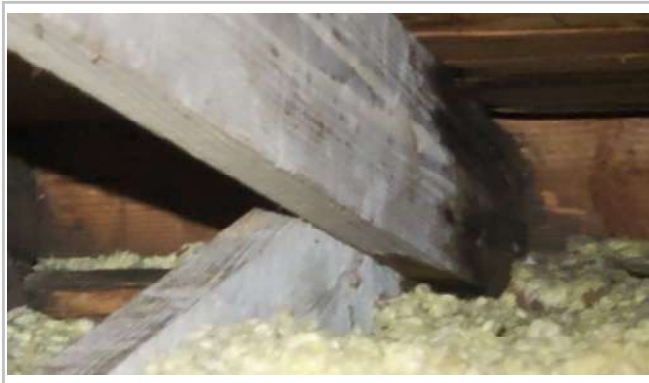
Attic beam has wood rot from previous leak. Repair/replace as needed.
