All Estate Home Inspection

13800 SW 174 ST Miami FL 33177

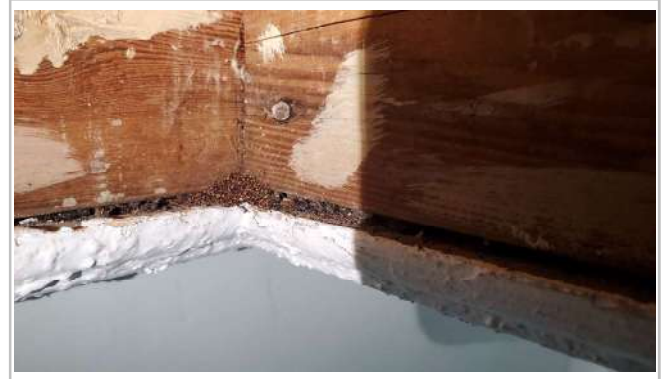
Found termite droppings and wings in main house attic. Termite tent recommended.

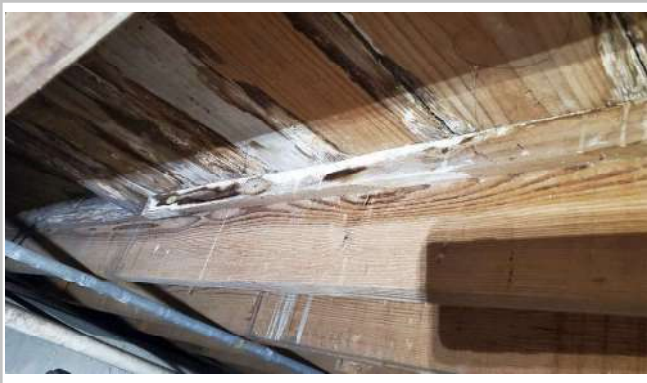
Crawl space underneath wood has wood rot and water stains. Repair/replace as needed.

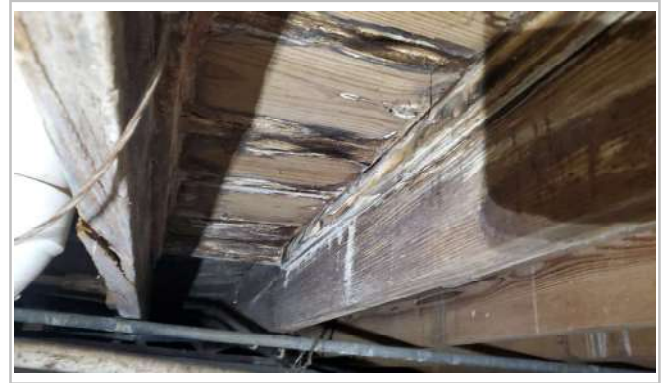
Crawl space underneath wood has wood rot and water stains. Repair/replace as needed.

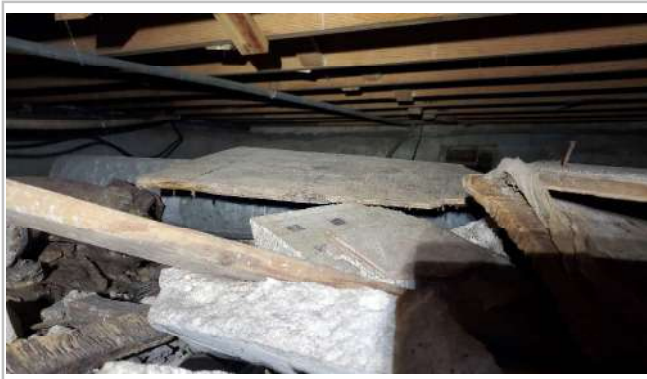
Crawl space debris left overs view.

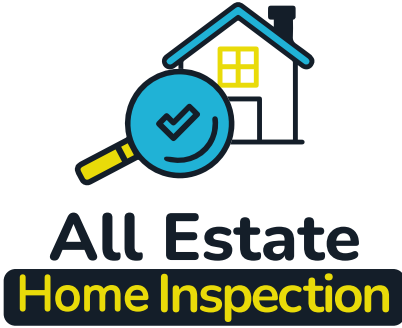
" A SECURE MOVE WITH ALL ESTATE "
